Examination of Nonchromate Conversion Coatings for Aluminum Armor From Three Final Candidates Using Accelerated Corrosion and Adhesion Test Methods

ARL-TR-2601 September 2001

Army Research Laboratory

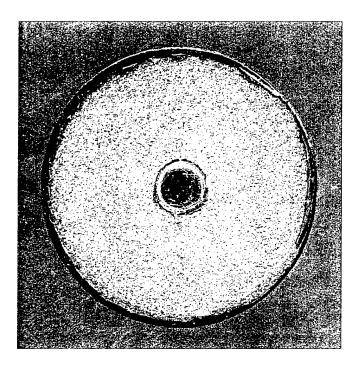
Figure 7. Pull-off adhesion test interlayer failure on Organosilane-treated Al 5083 after exposure at Camp Roberts, CA (2960 psi) ($2\times$ magnification).

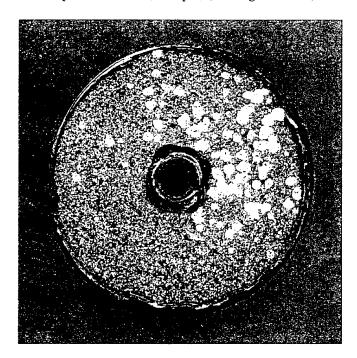
Figure 8. Pull-off adhesion test interlayer/substrate failure on Organosilane-treated Al 7039 after exposure at Camp Roberts, CA (2270 psi) (2x magnification).

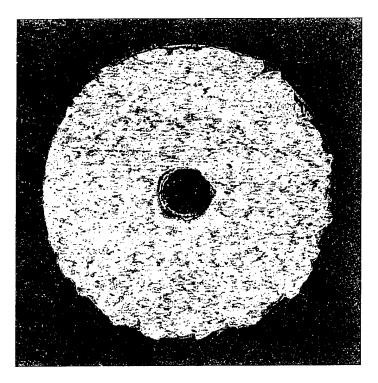
For initial unexposed conditions, all of the pretreatments had excellent adhesion in excess of 3000 psi on Al 5083. For Al 7039, Brent and Alodine 5200 pretreatments had poor adhesion as a result of delamination between substrate and primer with readings of 520 psi and 630 psi, respectively. As in dry adhesion methods, Organosilane was the only pretreatment to which paint adhered on 7039 with a measurement of 2620 psi.

Figure 9. Pull-off adhesion test substrate failure on Brent-treated Al 7039 after exposure at Camp Roberts, CA (570 psi) (2x magnification).

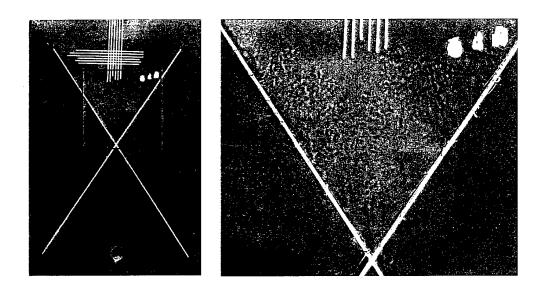
- (2) The Organosilane conversion coating showed significantly reduced adhesion strength (ASTM D3359 [6], ASTM D4541 [7]) as well as poor corrosion resistance (ASTM B117 [4], ATC Test Track) vs. the other pretreatments on Al 5083.

Figure 15. Corrosion damage on Organosilane-treated scribed CARC-coated AL 5083 panels at 3000 hr.

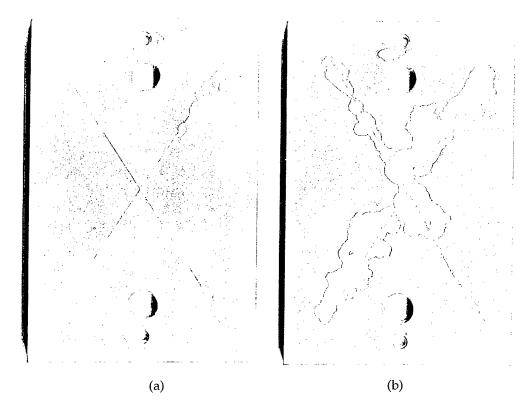
Figure 20. Corrosion/delamination damage of (a) Alodine 5200 vs. (b) Brent on Al 7039 at four-phases ATC test track exposure.

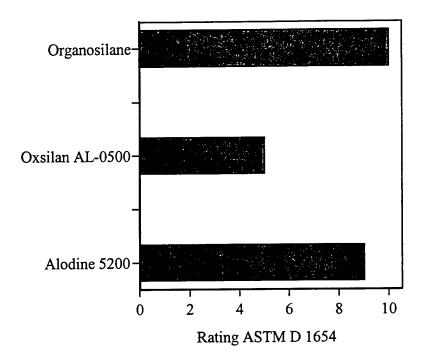
Figure 30. Corrosion/delamination damage on seafoam green-coated Al 5083 bilge cover at seven-phases ATC test track exposure (greater is better).

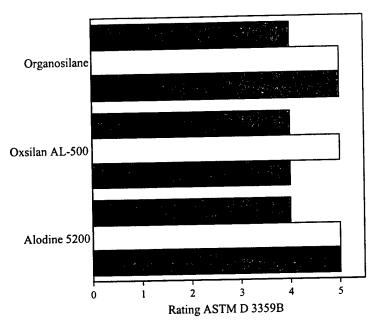
For post-durability exposure at Camp Roberts, dry adhesion measurements for panels and components were performed in unaffected zones free from chips or abrasions. Adhesion for all three pretreatments was very good ranging from 4 to 5 for all panels. As expected, adhesion problems occurred for Al 7039 panels. Organosilane was best with ratings ranging from 2 to 3. Brent and Alodine 5200-treated panels rated worst with scattered ratings weighted toward the low end of the 0 to 3 range. Adhesion for Al 6061 panels was very good for all three pretreatments ranging from 4 to 5. Adhesion for the pretreated Bradley components was very good for all treatments rating 4 to 5 except for Organosilane on a headlight guard which rated fair at a 3 (Figures 50–53).

Figure 50. Dry adhesion ratings for Bradley-mounted Al 5083 panels after 4000-mi durability exposure at Camp Roberts, CA (greater is better).

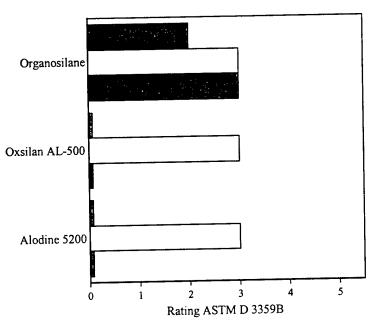
Figure 51. Dry adhesion ratings for Bradley-mounted Al 7039 panels after 4000-mi durability exposure at Camp Roberts, CA (greater is better).

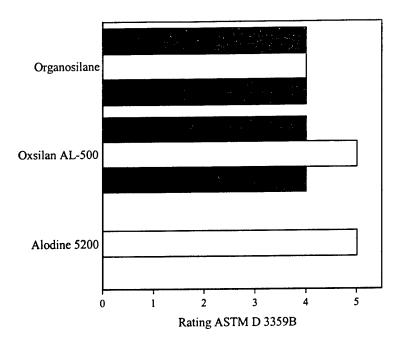
Figure 52. Dry adhesion ratings for Bradley-mounted Al 6061 panels after 4000-mi durability exposure at Camp Roberts, CA (greater is better).

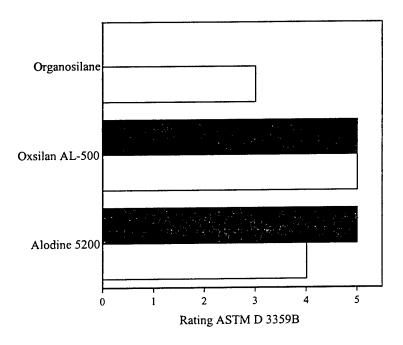
Figure 53. Dry adhesion ratings for mixed Al 5083 Bradley components after 4000-mi durability exposure at Camp Roberts, CA (greater is better).
